## Royal Observer Corps

Written by Nick Catford.

Since its inception in 1925 as an integral part of the UK air defence system, the primary role of the Royal Observer Corps (ROC) was the recognition and identification of hostile aircraft. With the start of the cold war and the increasing threat of nuclear attack in the 1950's, the ROC was given the added responsibility of reporting nuclear bursts and monitoring fall-out which necessitated the construction of 1563 underground monitoring posts throughout Great Britain & Northern Ireland. These are the subject of this archaeological report.

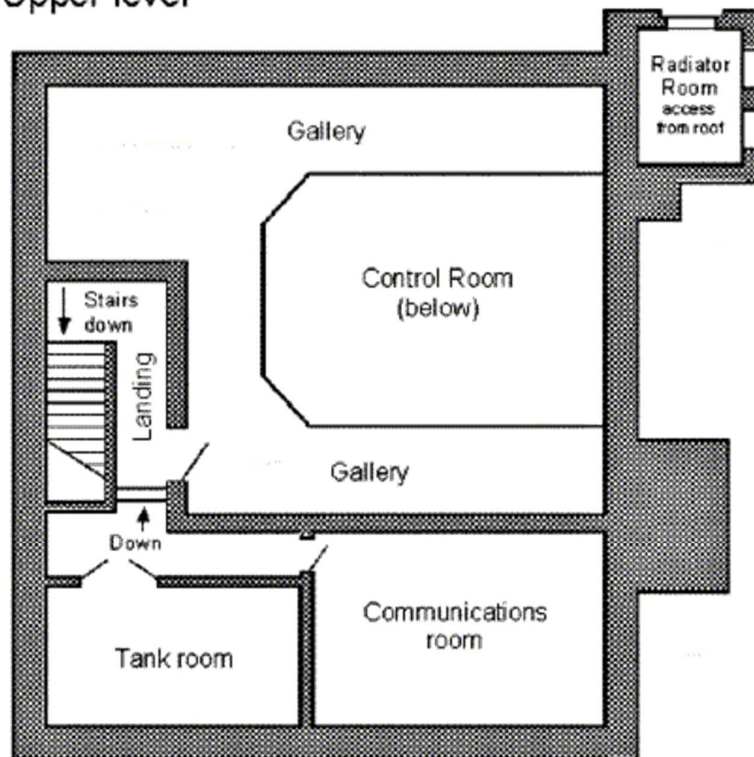
### ROC Group Headquarters — protected surface blockhouse Upper level

There were two types of purpose built protected centre, a semi-sunken two level bunker or a two level surface blockhouse. Each had an operations room with an upper gallery around three sides (in a bunker you went down to the lower floor while in a blockhouse you go up to the gallery), stand-by generator plant, sleeping accommodation, kitchen and dining room, air conditioning, air filters, communications, water and food storage etc. When sealed the centre had to be self sufficient for a week under fall-out conditions.

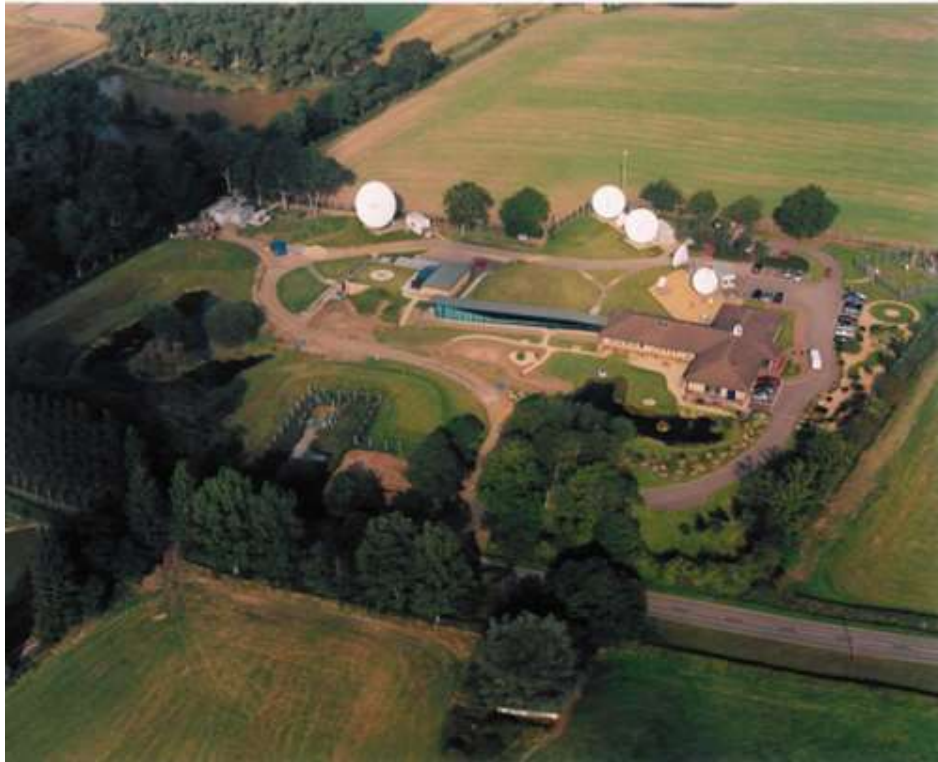
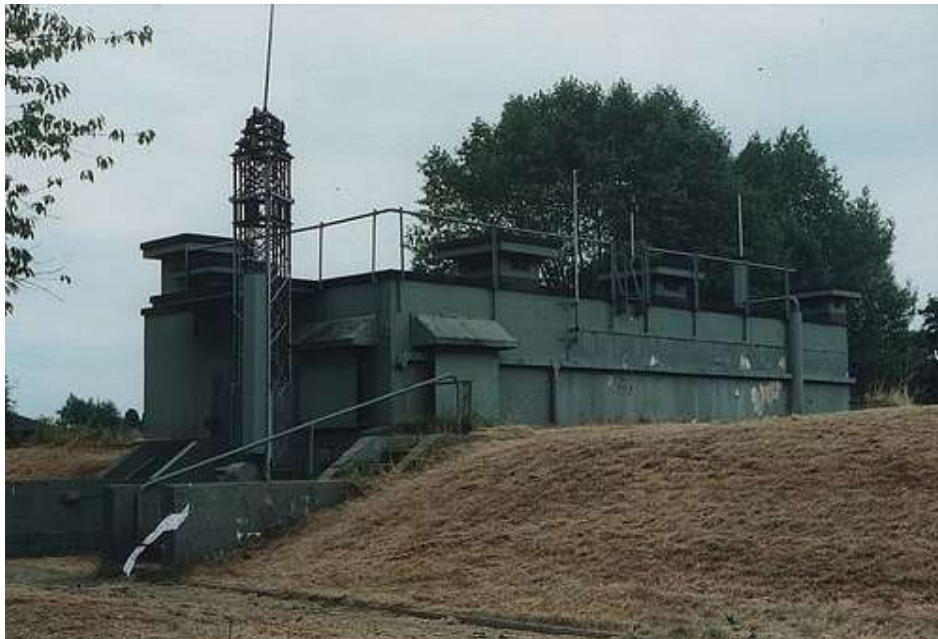
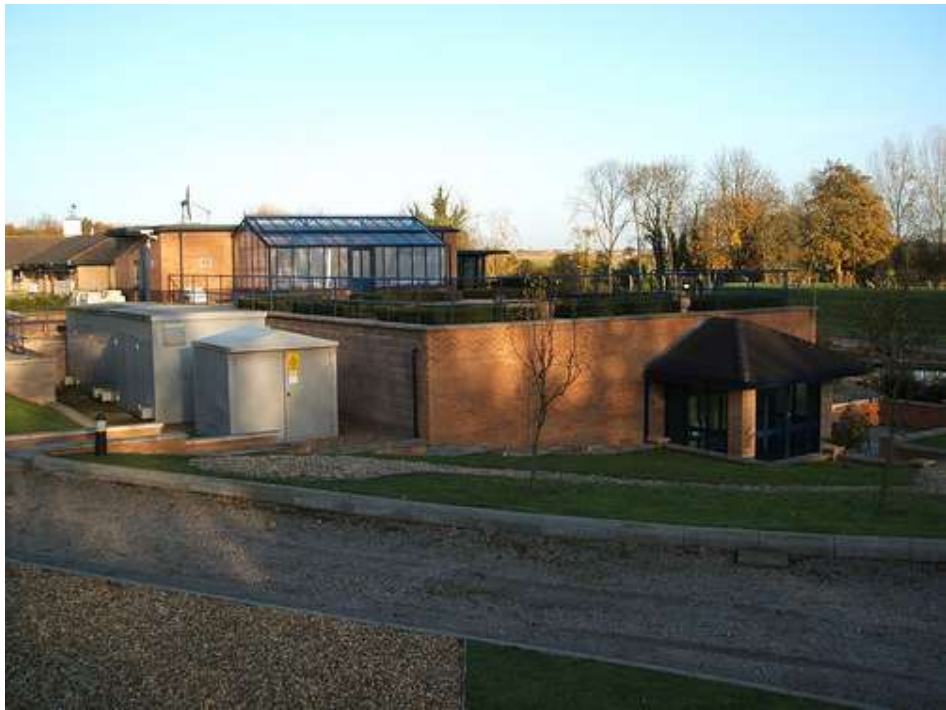
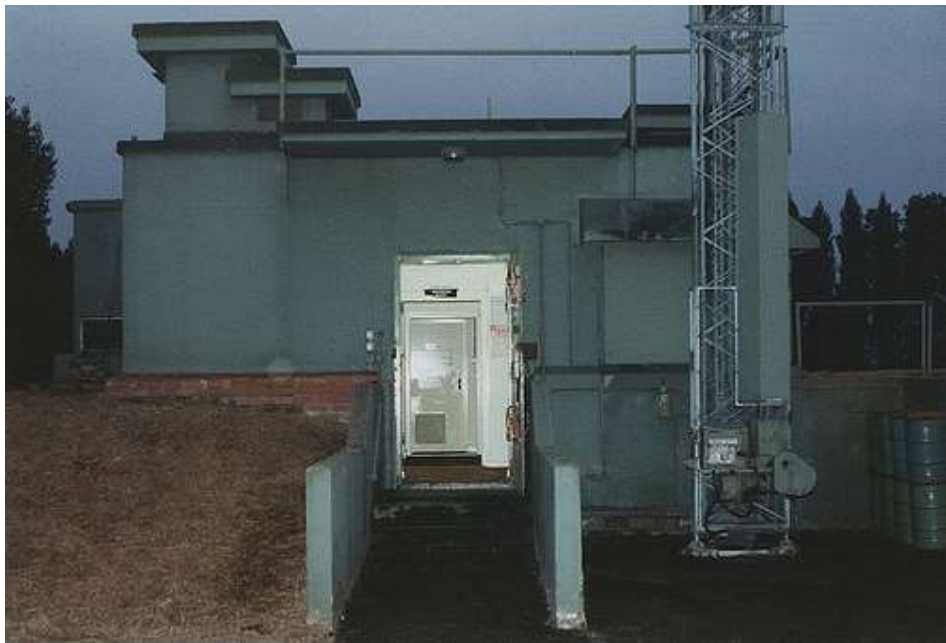
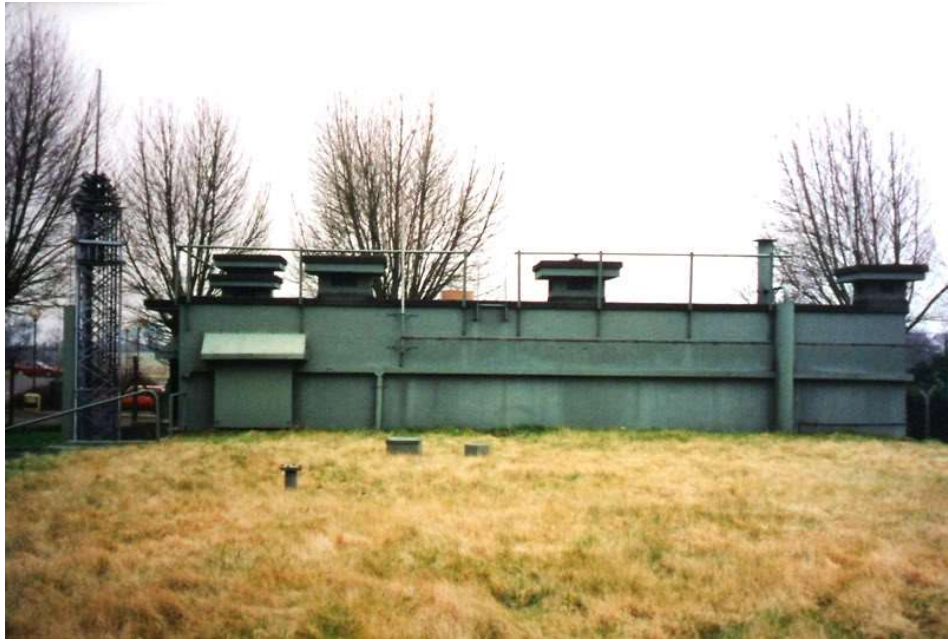
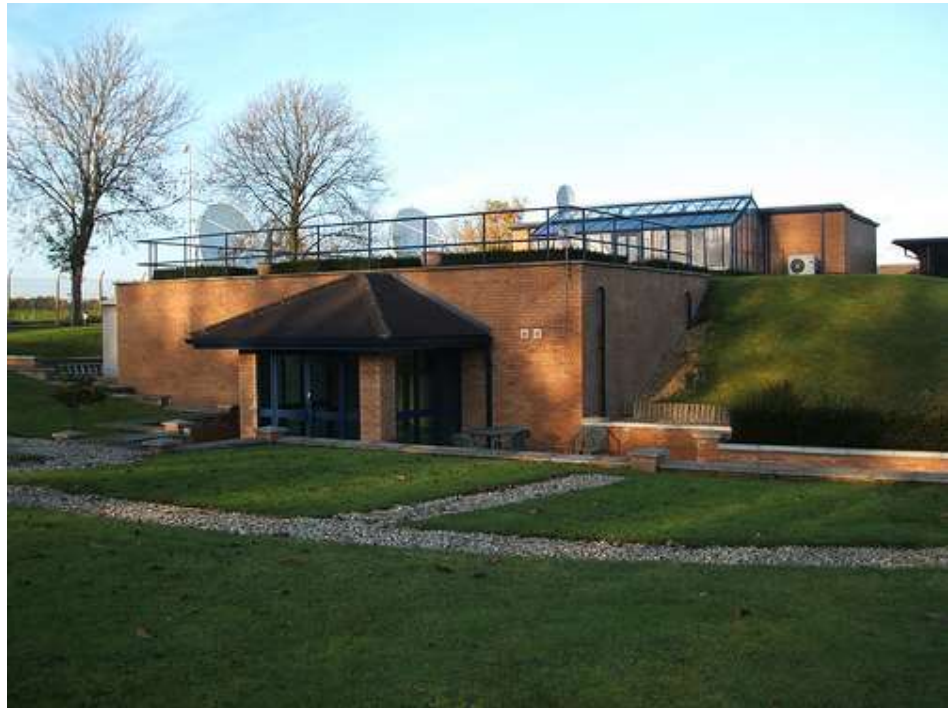
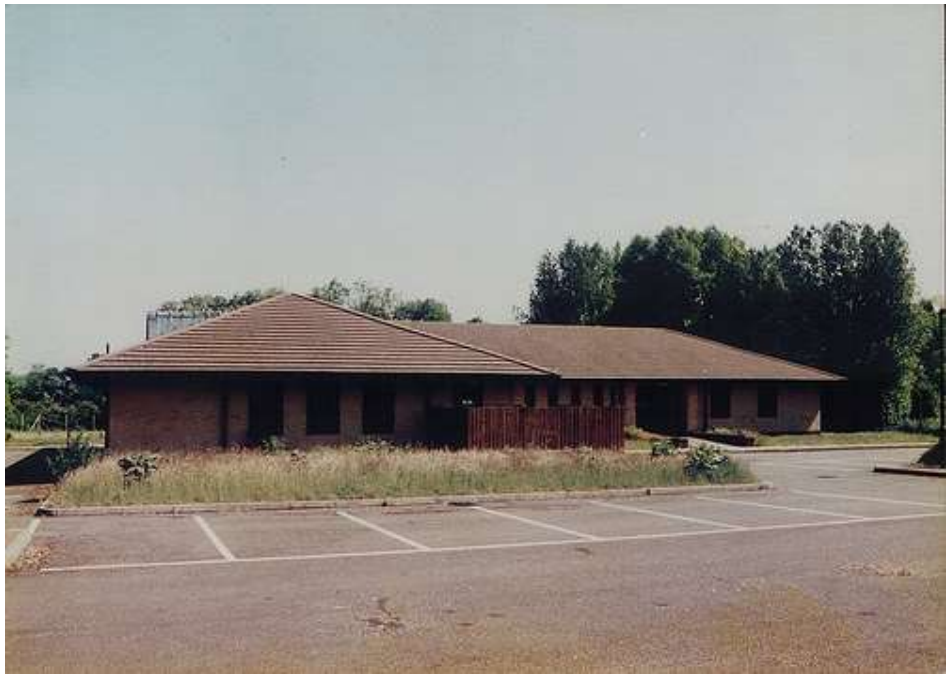
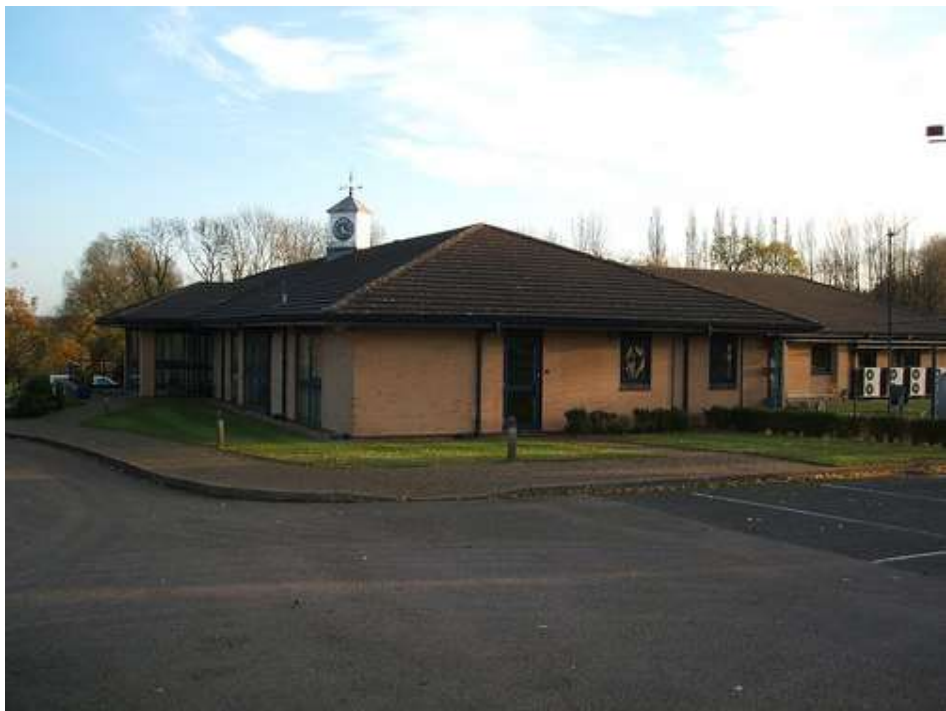
No 8 Group HQ pre and post refurbishment

The bunker is of the semi-sunken variety with steps up to the original entrance blockhouse which contained the decontamination and filter rooms. Apart from the original porch which remains in place, the building has now been clad in brick. The three rooms at this level remain intact though completely stripped of original fittings. Stairs lead down to the main east - west spine corridor. At the bottom of the stairs a new entrance has been constructed in the east wall which links to a new 50 yard covered walkway to the admin. block. All the rooms on the south side of the corridor (dormitory's and toilets) have been gutted and refurbished. The corridor wall itself has been removed and a new curving wall built in its place. The former officers' room at the western end has become the new toilet. The rooms along the northern side of the corridor are still largely intact but completely refurbished with lowered ceilings although it is still possible to identify the plant room, generator room, kitchen, canteen, BT room and balcony.

The balcony is being retained as an area for visitors to look down into the new 'control room'. All the woodwork on the balcony has been stripped out and replaced with chromed railings. At the northern end of the east - west spine corridor the former emergency exit has been rebuilt with a wooden porch.

The original stairs lead down to the bottom level where the control room is intact and is the hub of the new complex. The communications room alongside is intact and refurbished.

Much of this equipment however was moved into the protected 'bunker' which was completely refurbished during 2000.
